CITY OF CAMAS

# STREET TREE SUCCESSION PLAN

MARCH 2023

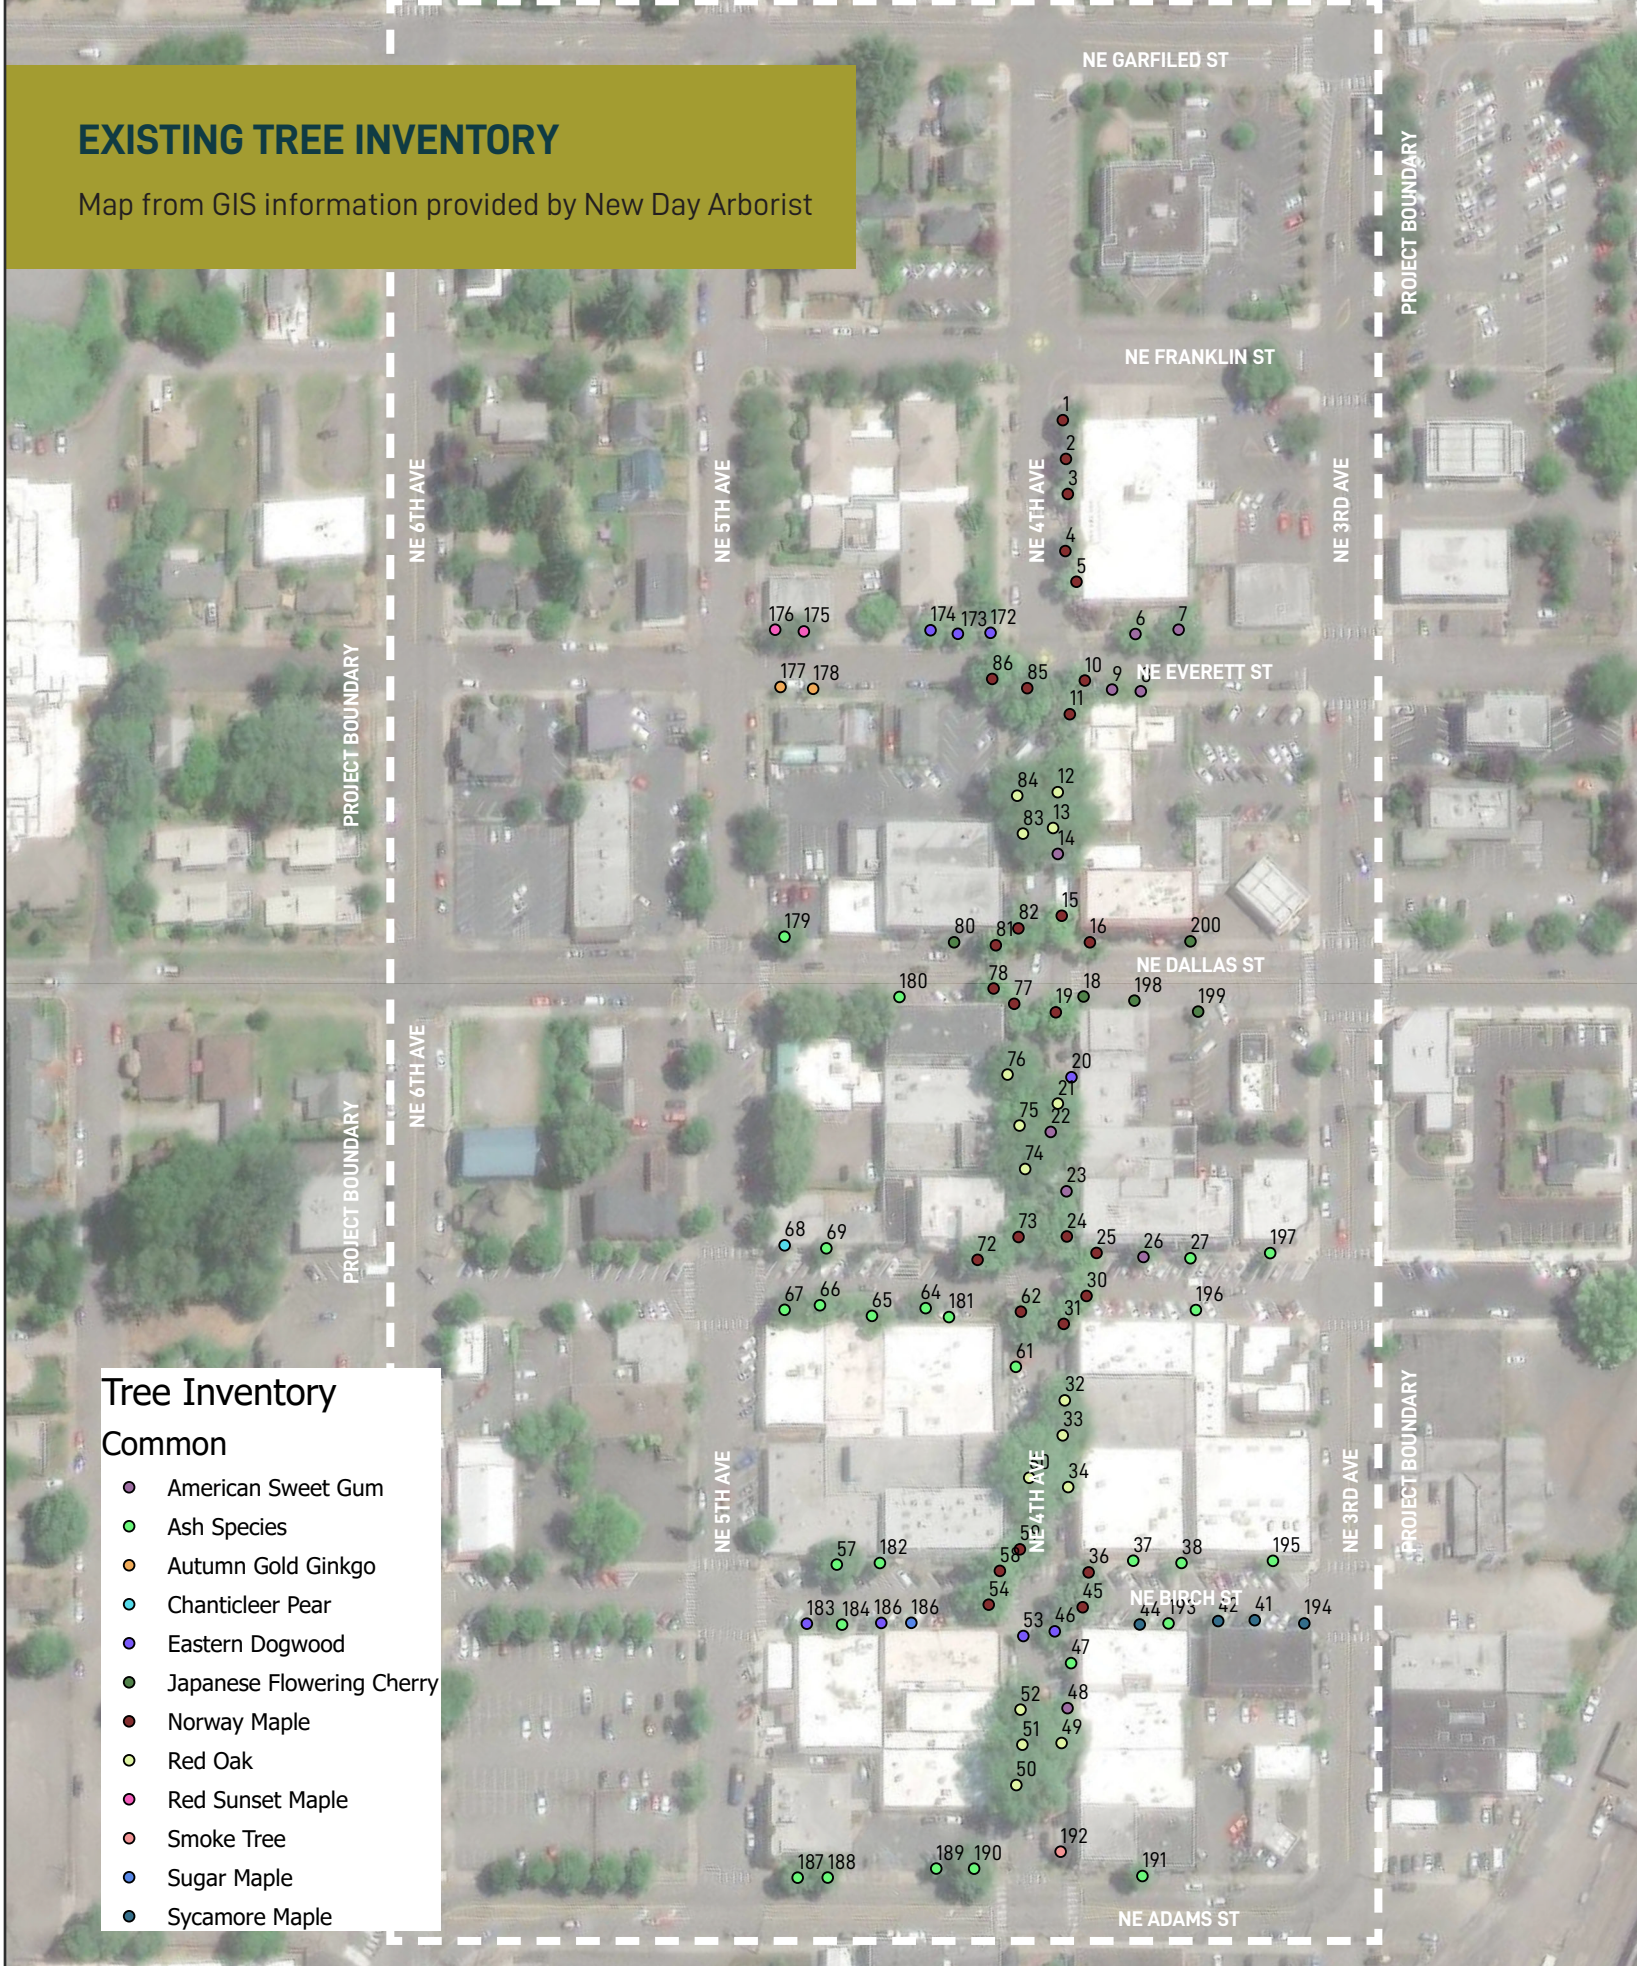
EXISTING TREE INVENTORY

The tree inventory noted a number of critical issues that helped inform this succession plan:

- Most species within the project area are Red Oaks (*Quercus rubra*) and Norway Maples.
- Most of the Norway Maple trees in the area are over-mature and showing signs of decline. The inventory recommends that the majority should be budgeted for removal and replacement.

- 80% of the trees have a concrete opening that is undersized for the size or age of the tree.
- Most of the Ash trees are small or stunted and appear to be under drought

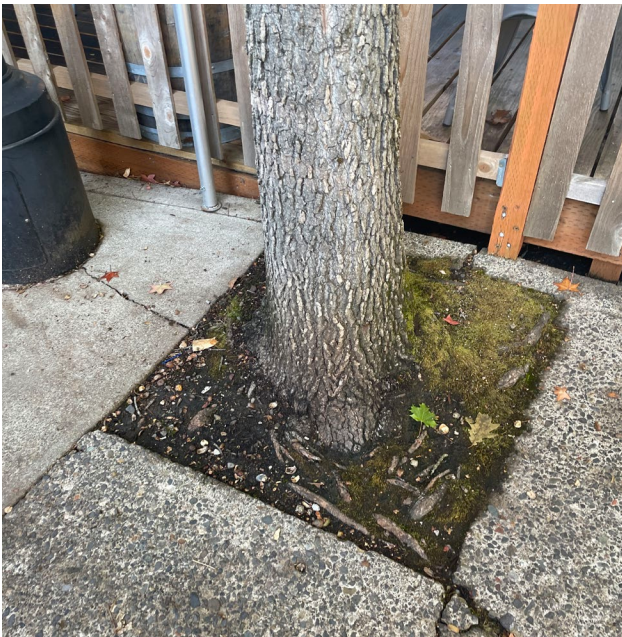
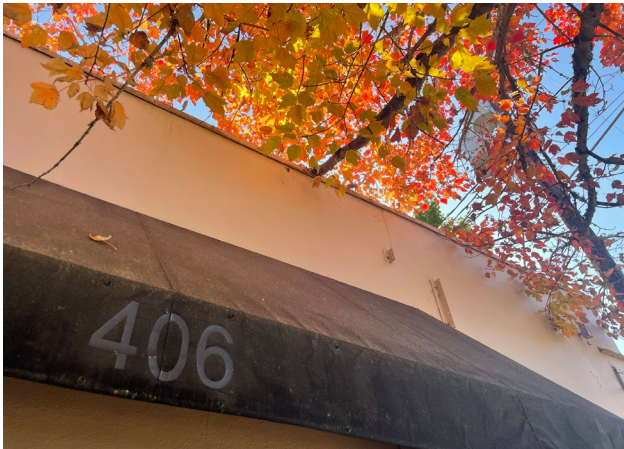
Soil Volume

Most trees in downtown Camas do not have enough soil and/or suffer from soil that is too compacted. The existing trees in this zone are often constrained to narrow ROW spaces between sidewalks and roadways.

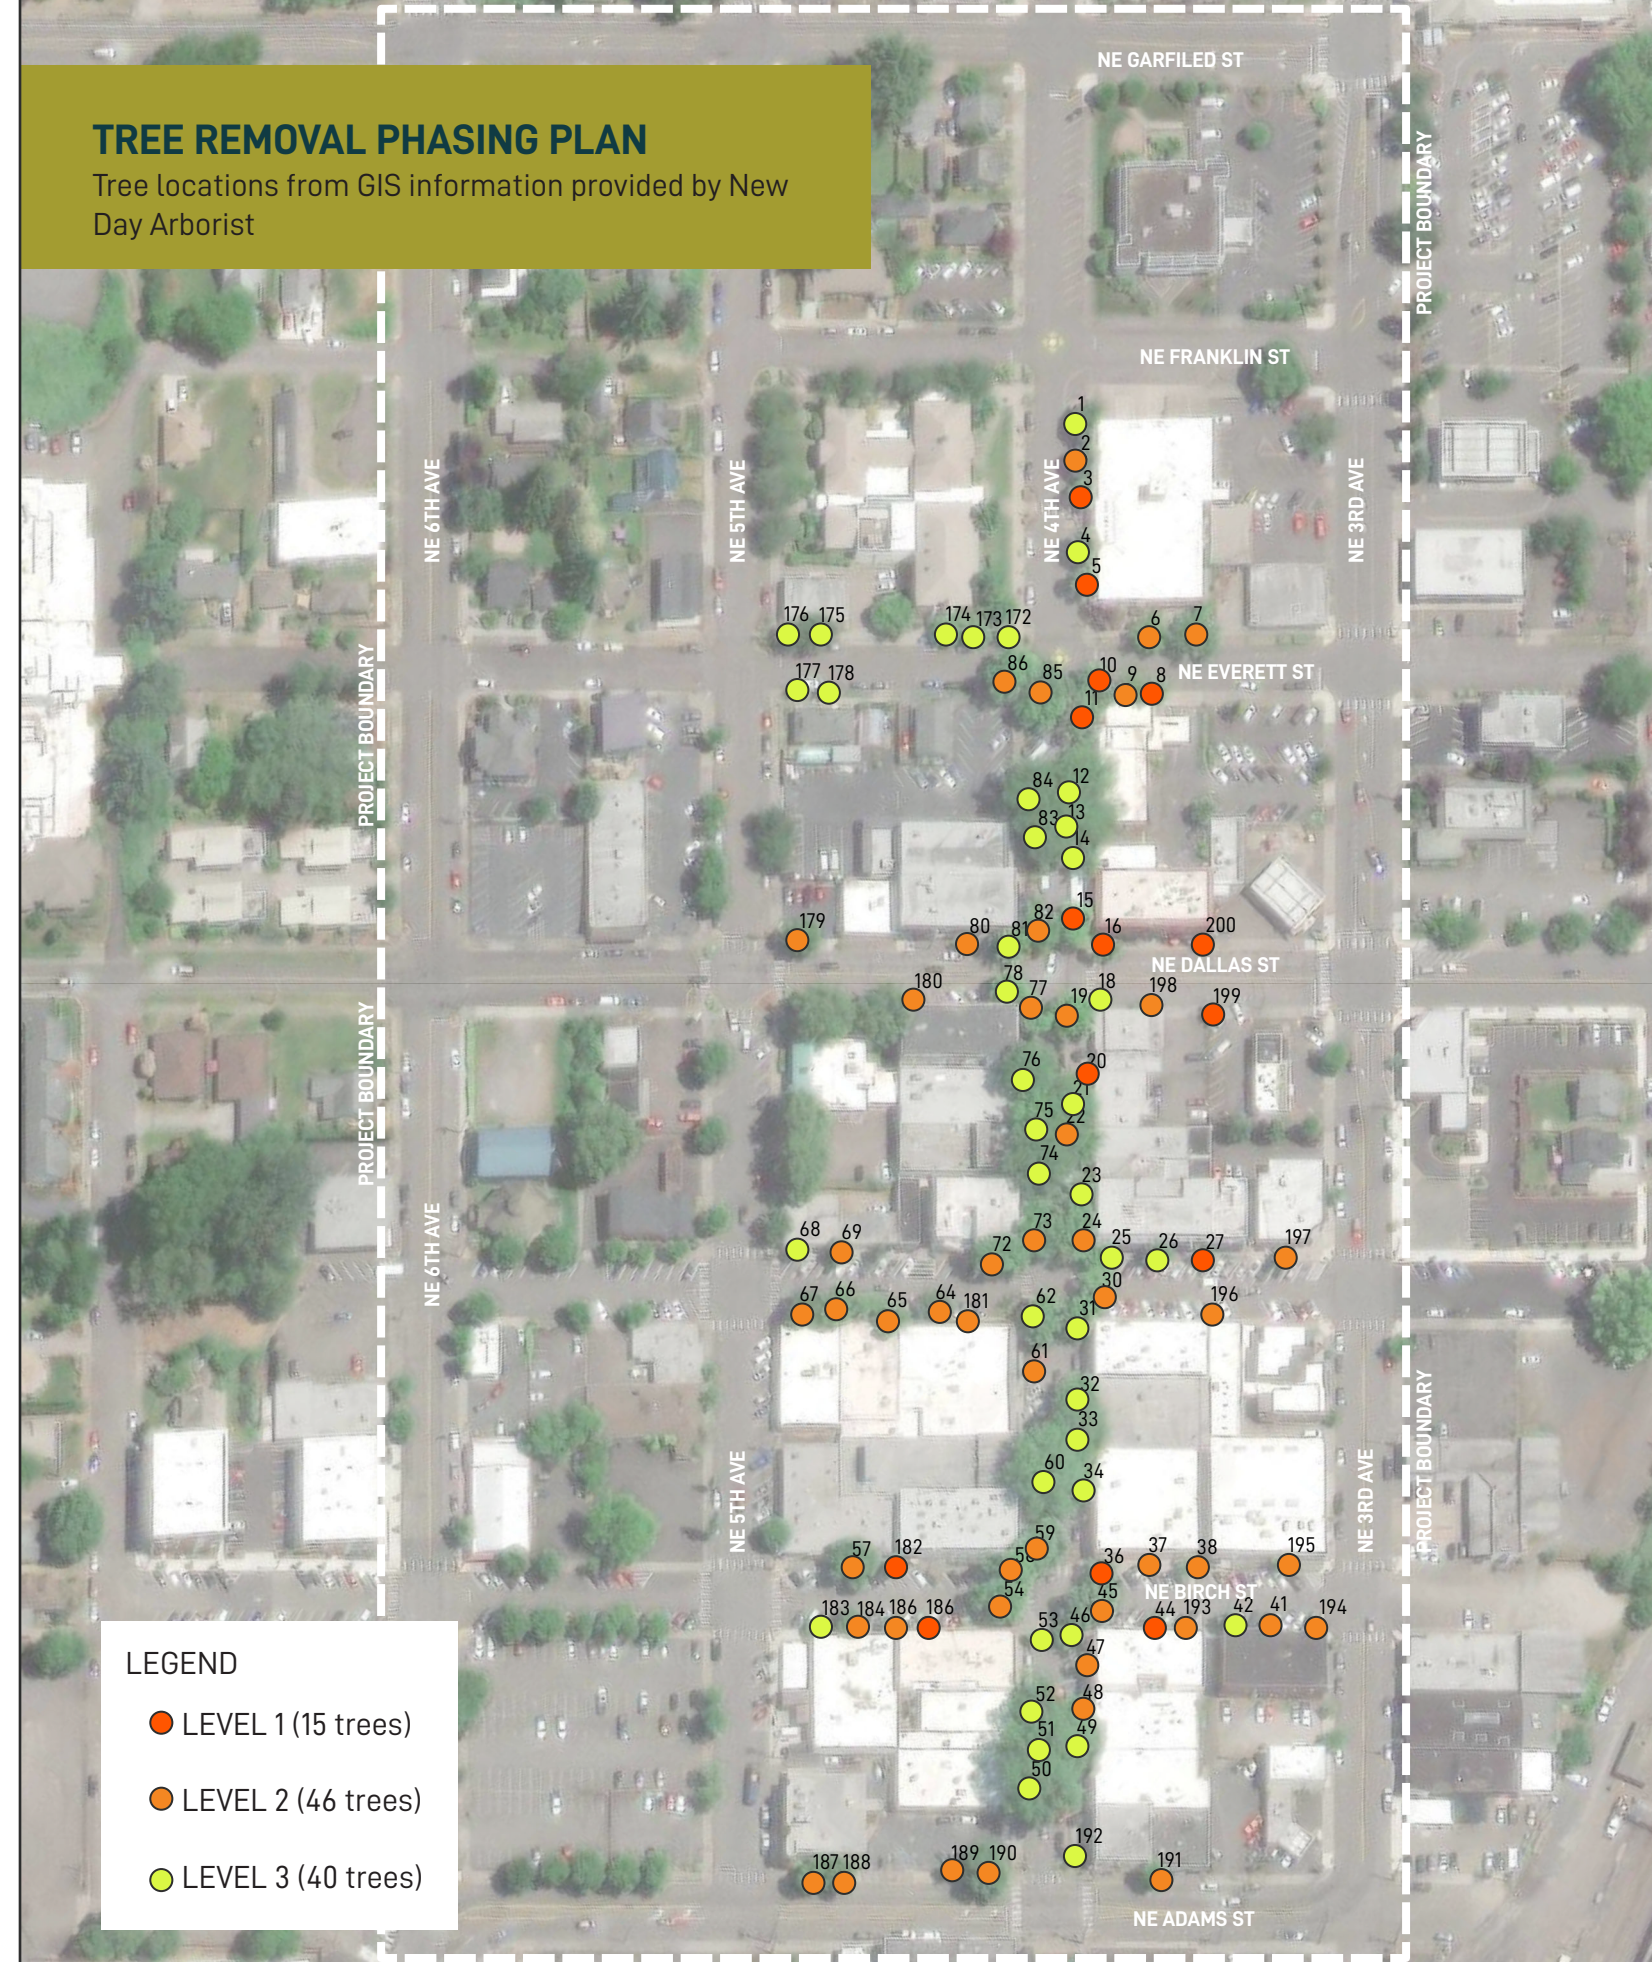
## TREE REMOVAL PHASING PLAN

These categories formed the baseline for the recommended removal timeline. Trees are recommended for removal and replacement based on the following criteria:

- Level 1: Urgent/High Risk/Hazard Tree  
Timeframe: 0-5 years  
Remove any dead or dying trees or trees classified as 'high risk'. Remove dead wood in the canopy of all species.
- Level 2: Moderate  
Timeframe: 5-10 years  
Tree is in moderate or poor health but does not immediately pose a risk. Remove and replace on an ongoing basis as time and budget allows. This category generally includes
- Level 3: Good  
Timeframe: Monitor  
Tree currently in good health. Monitor every 10 years. If tree health declines, consider moving it to Level 1 or Level 2 as needed.

In order to maintain phasing and diversity of age within the tree canopy, removal and replacement should not happen all in the same year.

Spatial context should also be taken into consideration. Generally, it is not recommended to remove all the trees on a single block face at the same time UNLESS where doing so will allow for infrastructure changes to support healthier trees in the long term.

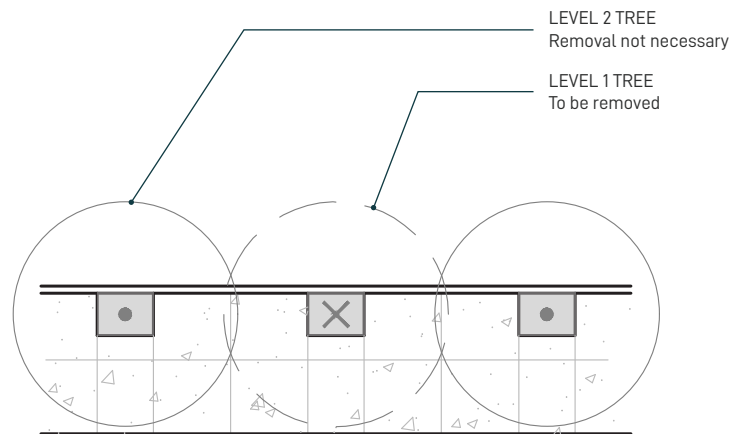
### Existing Conditions:

Sidewalk with street trees. Tree wells are undersized and soil volume is too small. One tree is listed as Level 1 and ready for removal.

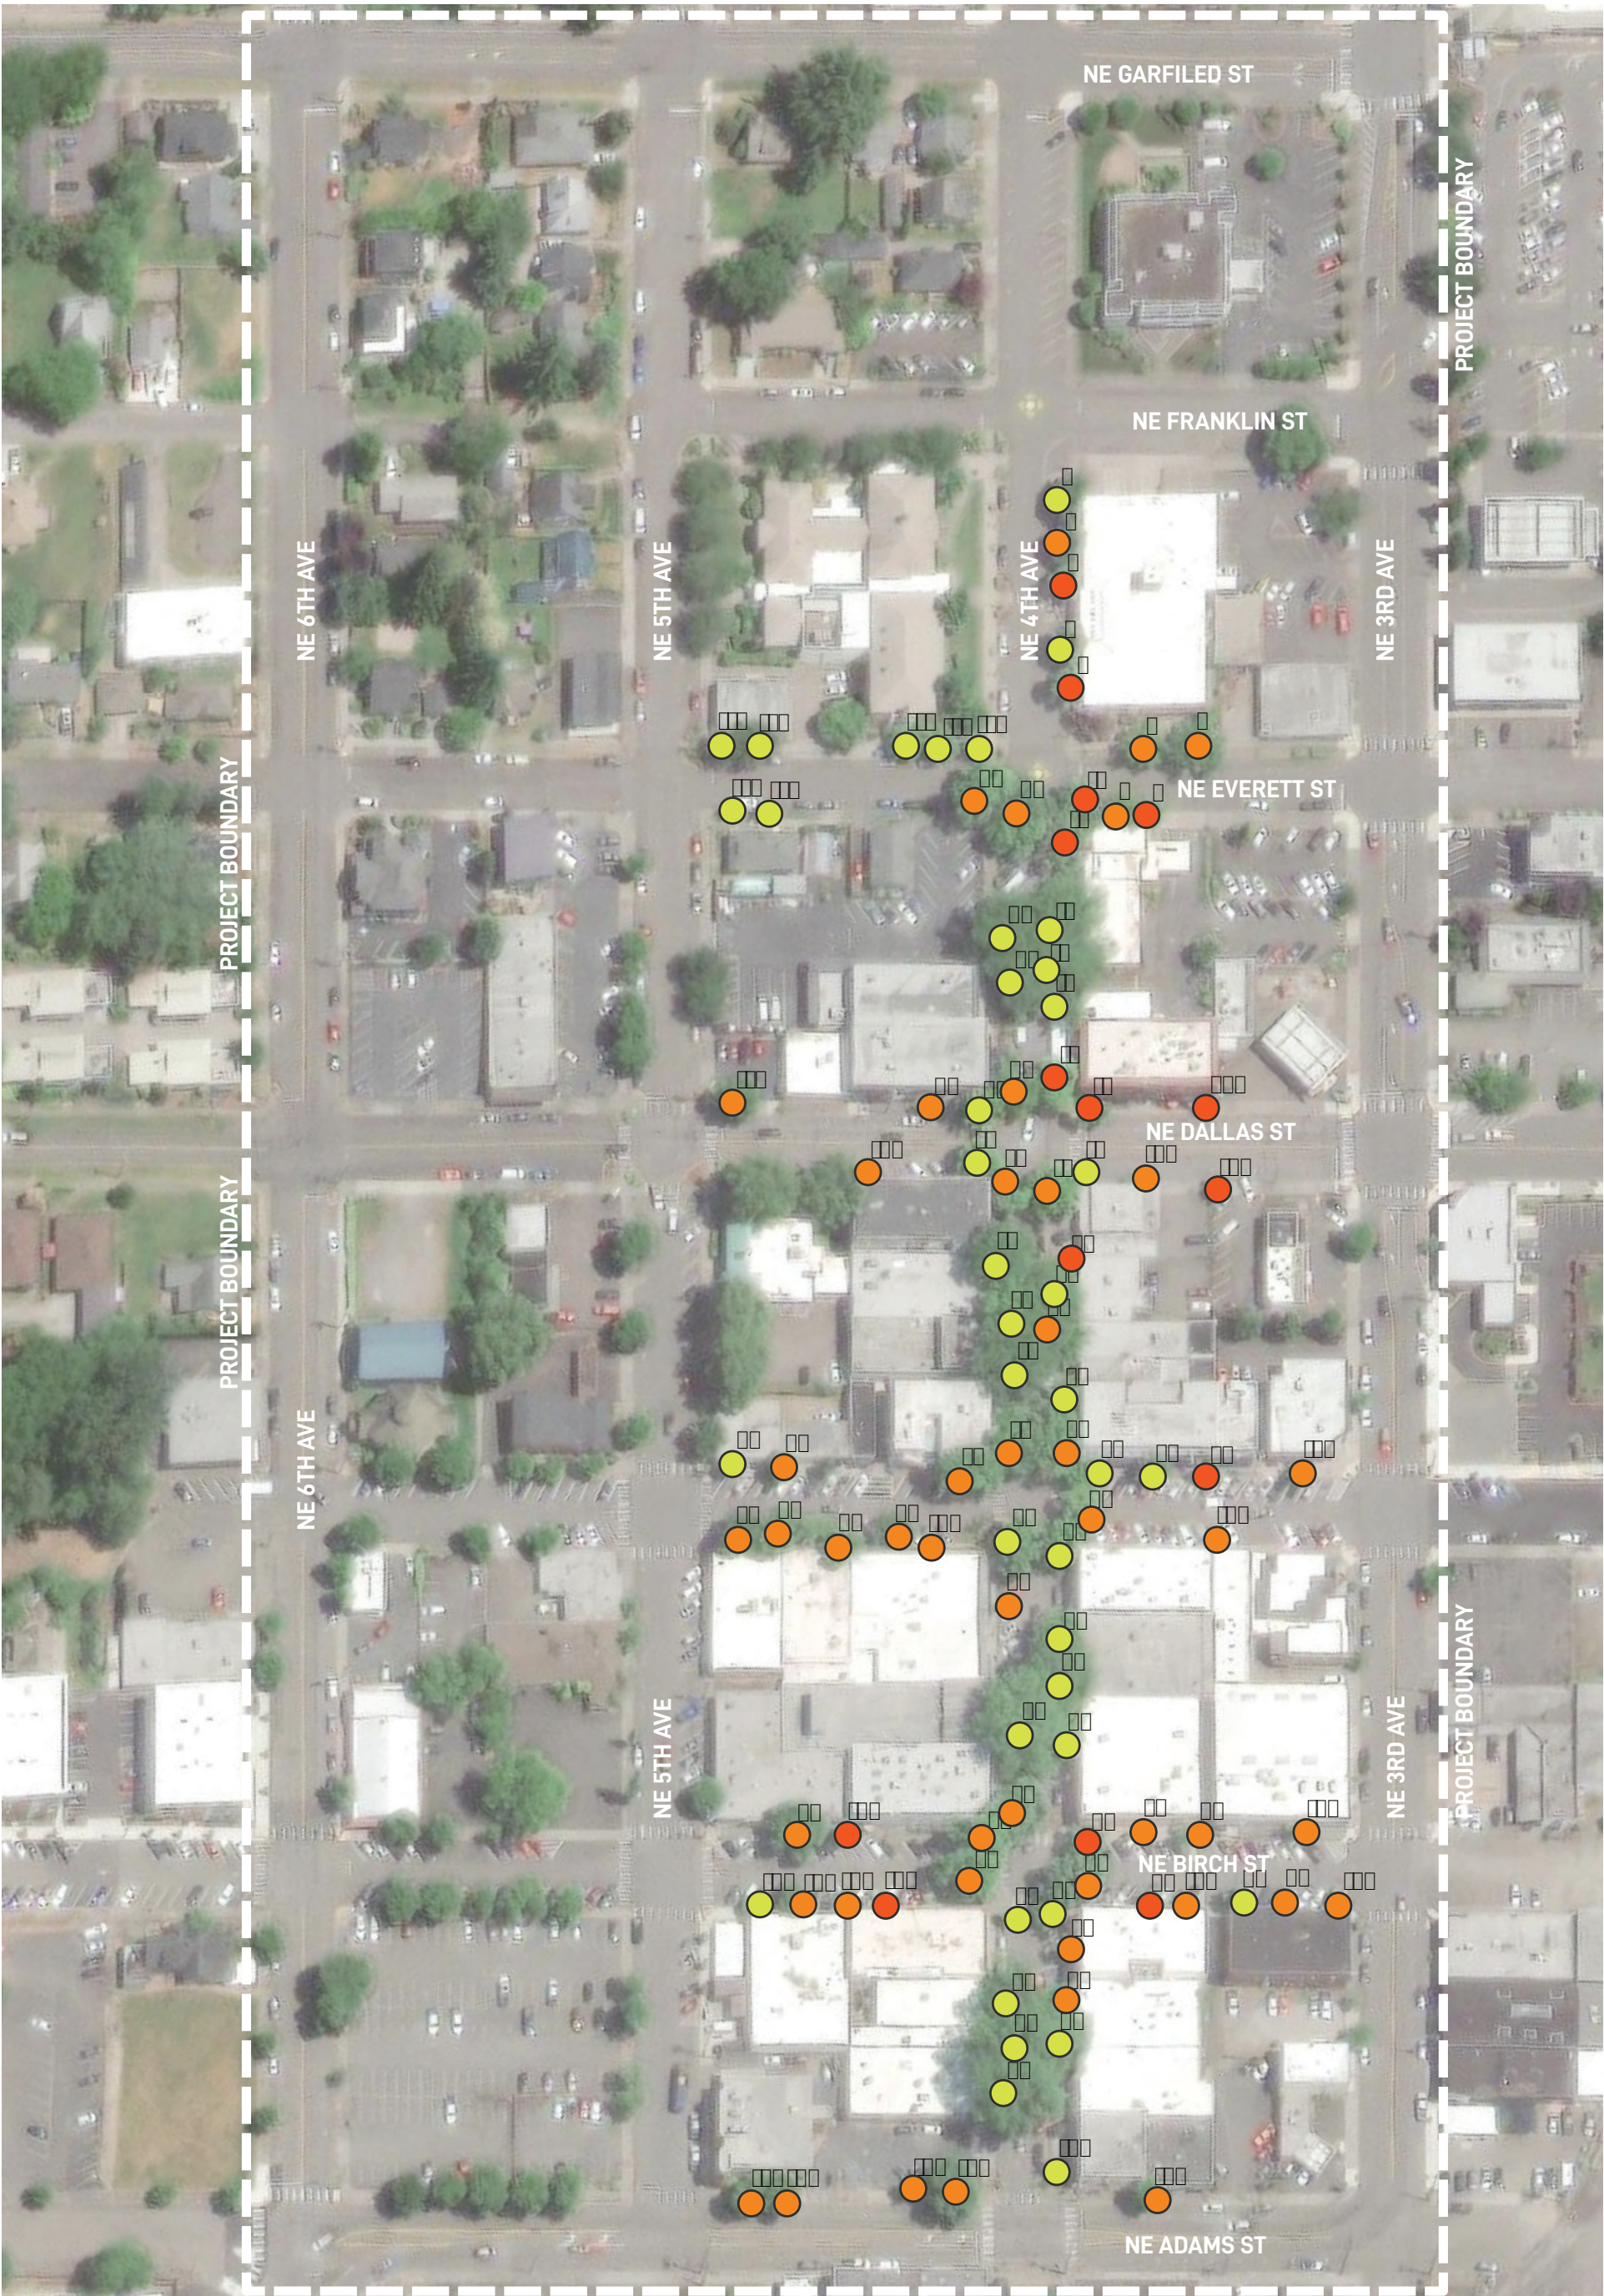
### TREE REMOVAL PHASING PLAN

- LEVEL 1 (15 trees)
- LEVEL 2 (46 trees)
- LEVEL 3 (40 trees)
